# **HILL END CHALK PIT**

## **GREENSPACE ACTION PLAN (GAP)**

**2018 – 2023**

Site Name: Hill End Chalk Pit

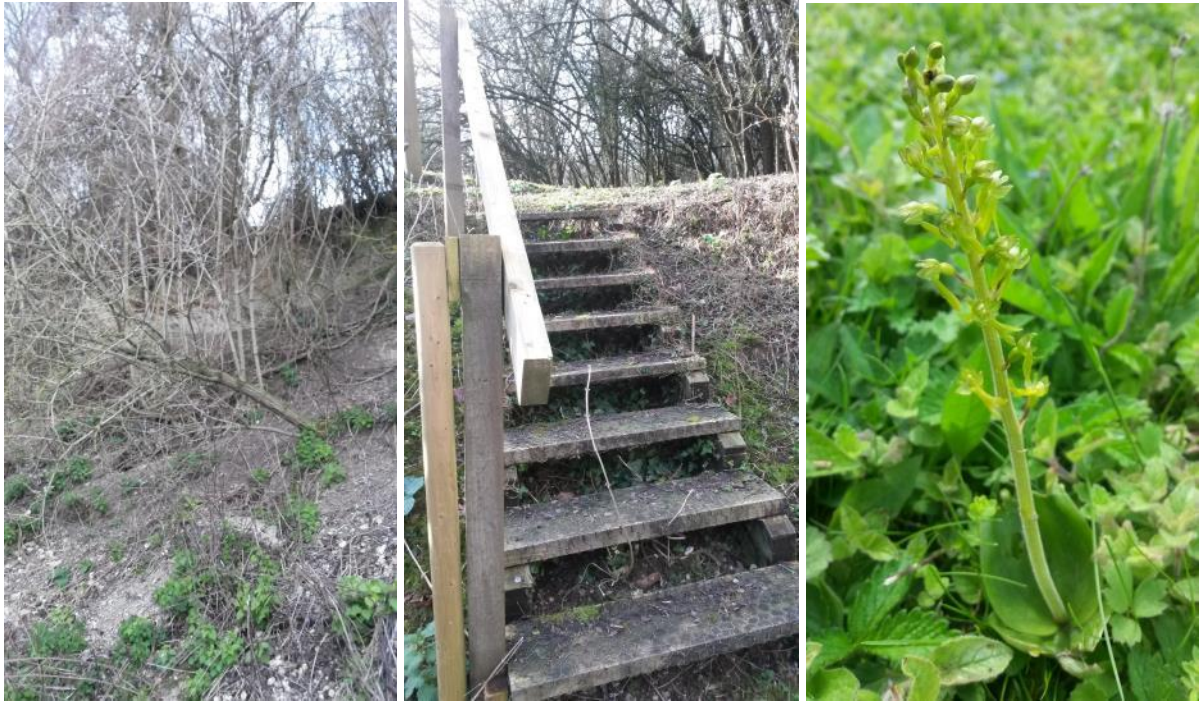
Exposed chalk face in pit, steps leading into pit and common twayblade

The open edges of the pit are fenced with post & rail fencing for safety. An HMWT interpretation panel is installed next to a flight of timber steps that lead into the pit. There is some maintenance required on the steps and fencing.

The geological interest of Hill End Chalk Pit is currently concealed by topsoil and vegetation. The chalk face should be opened up using an excavator, removing between 30cm and 50cm of topsoil to expose the important geological elements of the site. These are the Top Rock hardground (above the path within the pit), the Chalk Rock hardground (at the level of the path) and possibly the Caburn Marl (towards the floor of the pit). The face would be 3-5m wide, and its length would depend on the exact location of these important geological elements but might be 6-10m.
