# **WALSWORTH COMMON**GREENSPACE ACTION PLAN 2024 - 2029

#### **Greenspace Action Plans**

Greenspace Actions Plans (GAPs) are map-based management plans which specify activities that should take place on a site over a stated period of time; these activities will help to deliver the agreed aspirations which the site managers and stakeholders have identified for that site.

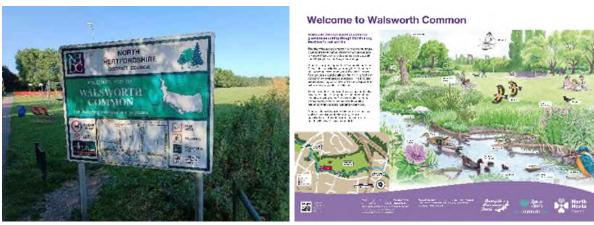
Images 8 and 9: old welcome sign and design for new interpretation.

Updated interpretation for Walsworth Common is currently in production and should be installed by March 2024. The two new interpretation panels at the eastern entrance from Woolgrove Road and the entrance from Cambridge Road will follow new North Herts Council branding. The ageing welcome sign at the eastern entrance from Woolgrove Road will be removed at the same time, which should reduce the cluttered appearance of signage in this area. Temporary fencing adjacent to the bridge should be replaced with permanent fencing to further improve the appearance of this entrance.

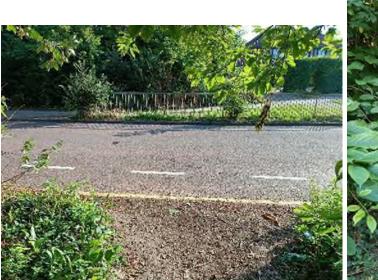
Images 10 and 11: western exit from Walsworth Common onto Woolgrove Road, and path leading onto Walsworth Common in this location.

The western pedestrian entrance from Woolgrove Road is overgrown with scrub and overhanging vegetation and would benefit from being cleared back to make this access point more welcoming and allow light into the path, helping it to dry it out in winter. A 1m margin should be cleared back each side of the path, providing headroom of 3m, wherever possible. Vegetation should be cut back for a few metres either side of the entrances to improve sight lines at the road crossing point.

These vegetation works would improve the entrance route within Walsworth Common, but the road crossing will remain difficult in the current arrangement, with restricted sight lines due to the railway bridge, and metal railings on the opposite side of the road which prevent easy access to the footway. Options to improve the road crossing in this area should be explored with Highways, particularly in the light of proposals associated with the approved outline planning application for a development at Highover Farm, which include implementing traffic signals and one-way vehicular operation and widening the footway under Woolgrove Road railway bridge.

Ref no.	Action	Obj. Ref	When	Lead	Delivery	Funding	Est. Cost	Spec. Ref.	Status
1.1	Cut back vegetation around the western access from the site onto Woolgrove Road and along the path onto Walsworth Common	A1, A3	Oct-Dec	CMS	Vols	NHC budget	Staff time

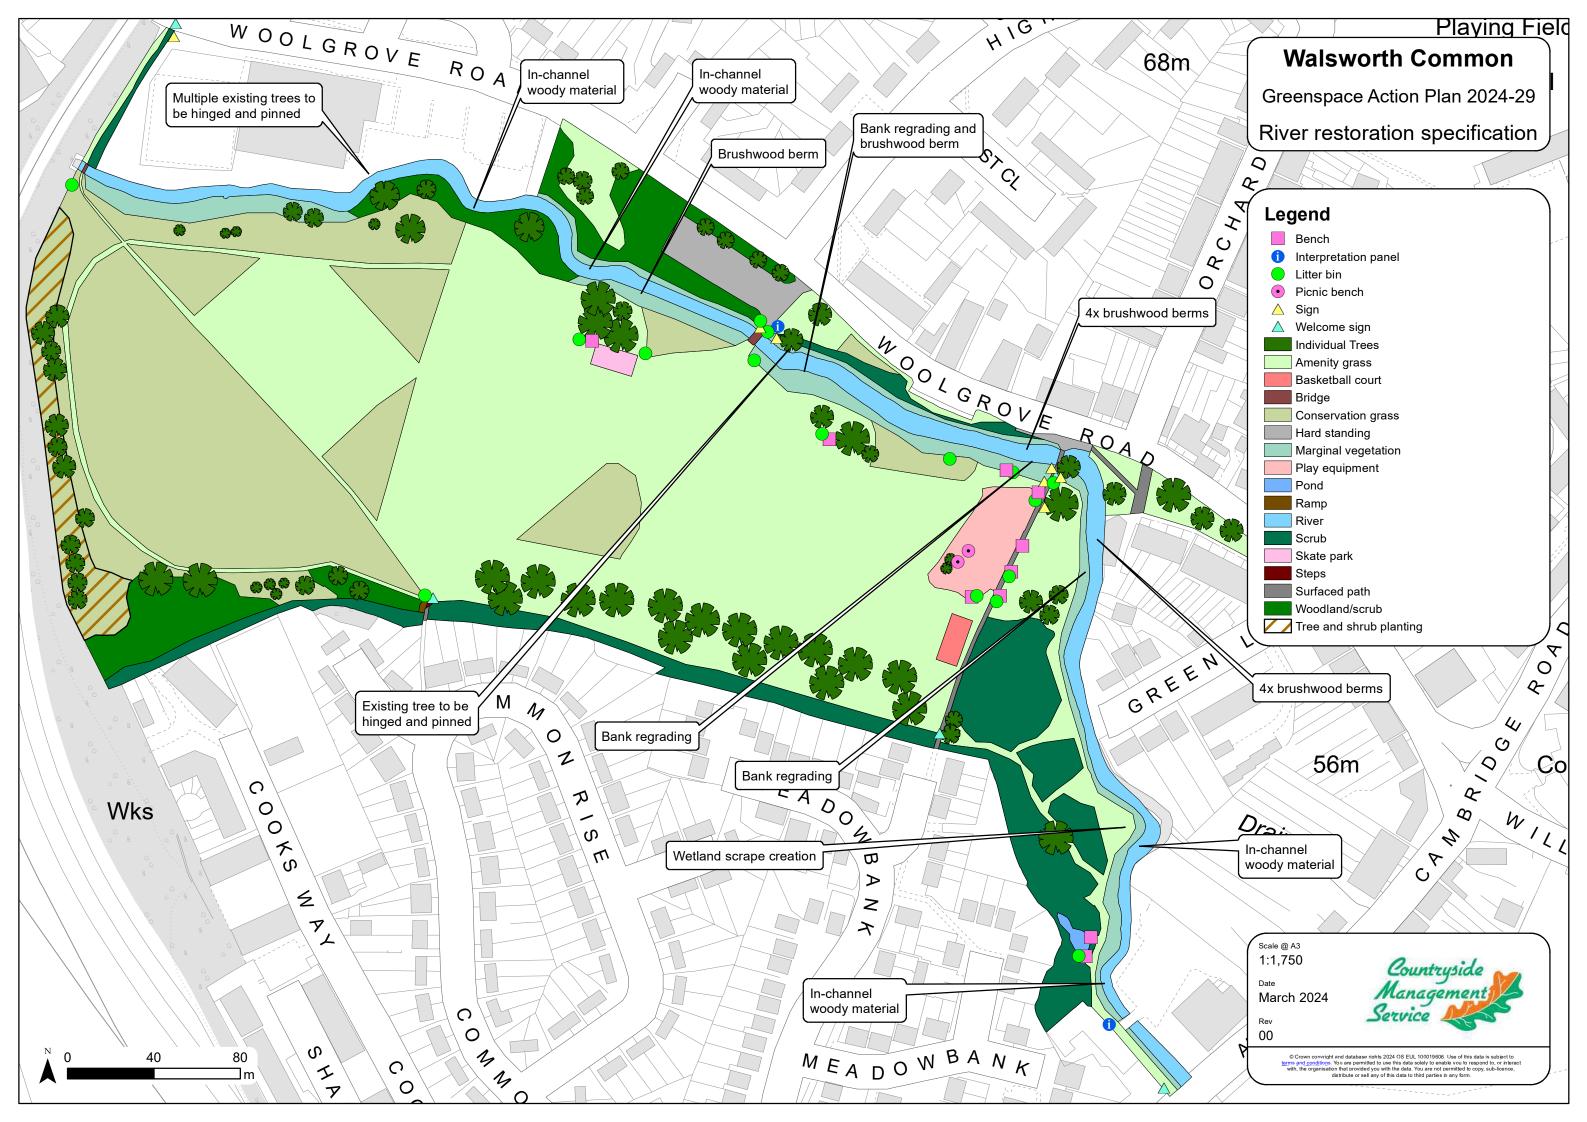
- 6.6.1 See map below for proposed locations.
- 6.6.2 Secure chestnut stakes around berm at 0.5m spacing.
- 6.6.3 Chestnut stakes should be untreated, 2m long, 75mm diameter, secured into bed at minimum depth 1.2m, excess post length above berm to be removed.
- 6.6.4 Site-won brash to be used for berm foundations between stakes and bank. This should be comprised of native species, e.g. hawthorn, hazel or willow, noting that willow is likely to regrow in-channel, requiring further management.
- 6.6.5 If bank regrading is planned, spoil from bank regrading can be used within berms, increasing speed of succession.

- 6.7.1 See map below for proposed locations.
- 6.7.2 Existing embankment regraded to form two-stage channel with minimum 1 in 3 slope for stability.
- 6.7.3 Two-stage design allows channel to expand during high flow events, inundating marginal shelves, inundating marginal shelves and improving connectivity with the flood plain.
- 6.7.4 Wetted area in marginal shelves encourages growth of native marginal vegetation. Colonisation should be accelerated by seeding of species such as lesser pond sedge, blue sedge, yellow flag iris, soft rush, purple loosestrife, reed canary grass and sweet reed grass.
- 6.7.5 Spoil created to be used on site within berms if feasible to reduce the need for offsite removal.

- 6.8.1 See map below for proposed location.
- 6.8.2 Excavate a scrape to a maximum depth of approximately 1m and area of approximately 100m2. Scrape to comprise an asymmetric and uneven profile. Majority of slopes are to be shallow, less than 1:5 (12°), and preferably less than 1:20 (3°).
- 6.8.3 The edge of the scrape is to have a wavy, asymmetrical edge.
- 6.8.4 The base of the scrape is to have a rough finish (not smooth) with bars, lumps and bumps, in order to allow colonisation by plants. Use of a tooth bucket may help to achieve the rough finish.
- 6.8.5 Spoil to be used on site within berms if feasible to reduce the need for offsite removal.
- 6.8.6 No planting is required as the scrape is to be left to natural colonisation.

- Construction of low-level brushwood berms at multiple points along the river to narrow the channel and increase diversity of flow conditions.
- Placement of large wood in channel to encourage local scour.
- Selective cutting, hinging and pinning of tree limbs into channel to narrow the channel.
- Re-grading the left bank in selected locations to create a more natural channel profile.
- Creation of new wetland scrape in an existing low point adjacent to the river, at the Cambridge Road end of the site.
